NASA SP-238

APOLLO 11

Mission Report

PREPARED BY
MISSION EVALUATION TEAM
NASA MANNED SPACECRAFT CENTER

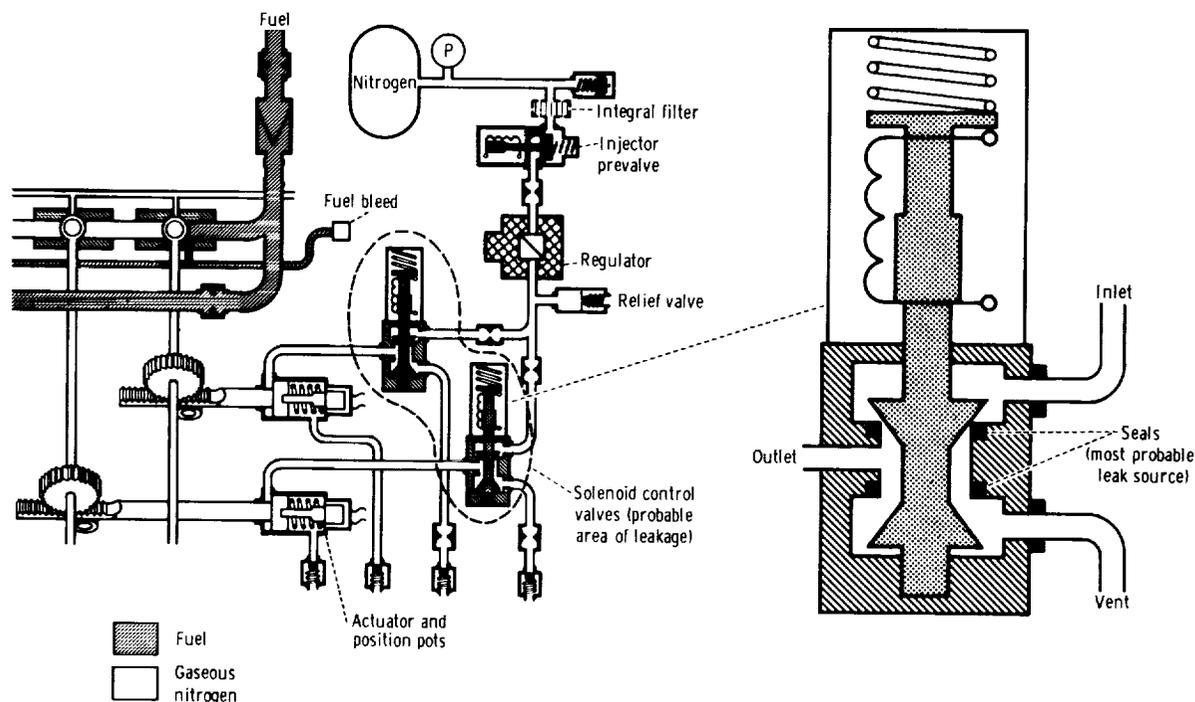
Figure 16-2.- Control for service propulsion propellants.

The fuel and oxidizer valves are controlled by actuators driven by nitrogen pressure. Figure 16-2 is representative of both nitrogen control systems. When power is applied to the service propulsion system in preparation for a maneuver, the injector pre valve is opened; however, pressure is not applied to the actuators, because the solenoid control valves are closed. When the engine is commanded on, the solenoid control valves are opened, pressure is applied to the actuator, and the rack on the actuator shaft drives a pinion gear to open the fuel and oxidizer valves. When the engine is commanded off, the solenoid control valve vents the actuator and closes the fuel and oxidizer valves.

The most probable cause of the problem was contamination of one of the components downstream of the injector pre valve, which isolates the nitrogen supply during nonfiring periods. The injector pre valve was not considered a problem source because it was opened 2 minutes before ignition, and no leakage occurred during that period. The possibility that the regulator and relief valve were leaking was also eliminated because pressure was applied to these components when the pre valve was opened.

It is concluded that the leakage was due to a contamination-induced failure of a solenoid control valve. The source of contamination is unknown; however, the contamination was apparently removed from the sealing surface during the valve closure for the first lunar orbit insertion maneuver (fig. 16-2). The suspected source is a contaminated facility manifold at the vendor's plant. Although an investigation of the prior failure indicated that the flight valve was not contaminated, the facility manifold is still considered a possible source of the contaminants.

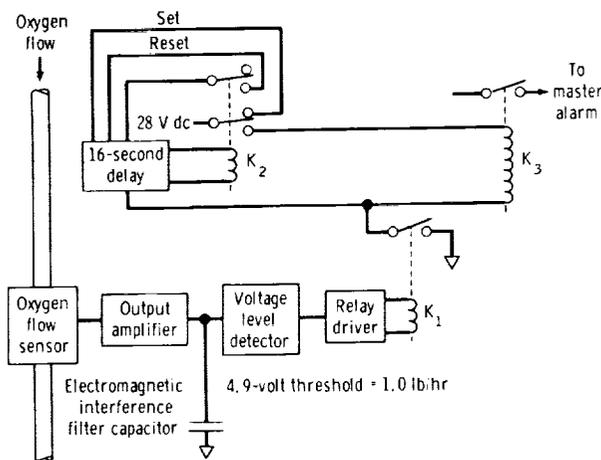
Figure 16-4.- Oxygen flow sensing circuit.

Oxygen flow master alarms.- During the initial lunar module pressurization, two master alarms were activated when the oxygen flow rate was decreasing from full scale. The same condition had been observed several times during altitude chamber tests and during subsequent troubleshooting. The cause of the problem could not be identified before launch, but the only consequence of the alarms was the nuisance factor. Figure 16-4 shows the basic elements of the oxygen flow sensing circuit. Note in figure 16-4 that, for a master alarm to occur, relay K1 must hold in for 16 seconds, after which time relays K2 and K3 will close, activating a master alarm.

The capacitor shown in figure 16-4 is actually a part of an electromagnetic interference filter and is required to prevent fluctuation of the amplifier output to the voltage detector. Without the capacitor, a slow change in flow rate in the vicinity of the threshold voltage of relay K1 will cause relay K1 to open and close continuously (chatter). Relay K2 has a slower dropout time than relay K1; therefore, if relay K1 is chattering, relay K2 may not be affected, so that the 16-second time delay continues to time out. Consequently, master alarms can be initiated without resetting of the 16-second timer.

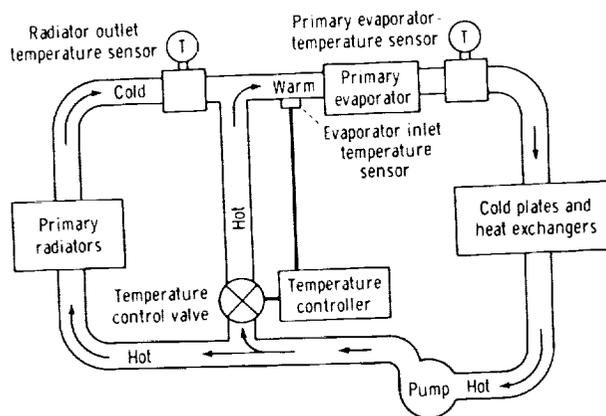
Figure 16-7.- Primary water/glycol coolant loop.

Glycol temperature control valve.- During lunar orbit operations, the glycol temperature control valve did not control the evaporator inlet temperature. The temperature of the water/glycol entering the evaporator is normally maintained above 42° F by the glycol temperature control valve, which mixes hot water/glycol with water/glycol returning from the radiators (fig. 16-7). As the radiator outlet temperature decreases, the temperature control valve opens to allow more hot glycol to mix with the cold fluid returning from the radiator. This procedure is followed to maintain the evaporator inlet temperature at 42° to 48° F. The control valve starts to close as the radiator outlet temperature increases and closes completely at evaporator inlet temperatures above 48° F. If the automatic temperature control system fails, manual operation of the temperature control valve is available by deactivating the automatic mode. This deactivation is accomplished by positioning the glycol evaporator temperature inlet switch from AUTO to MANUAL, which removes power from the control circuit.

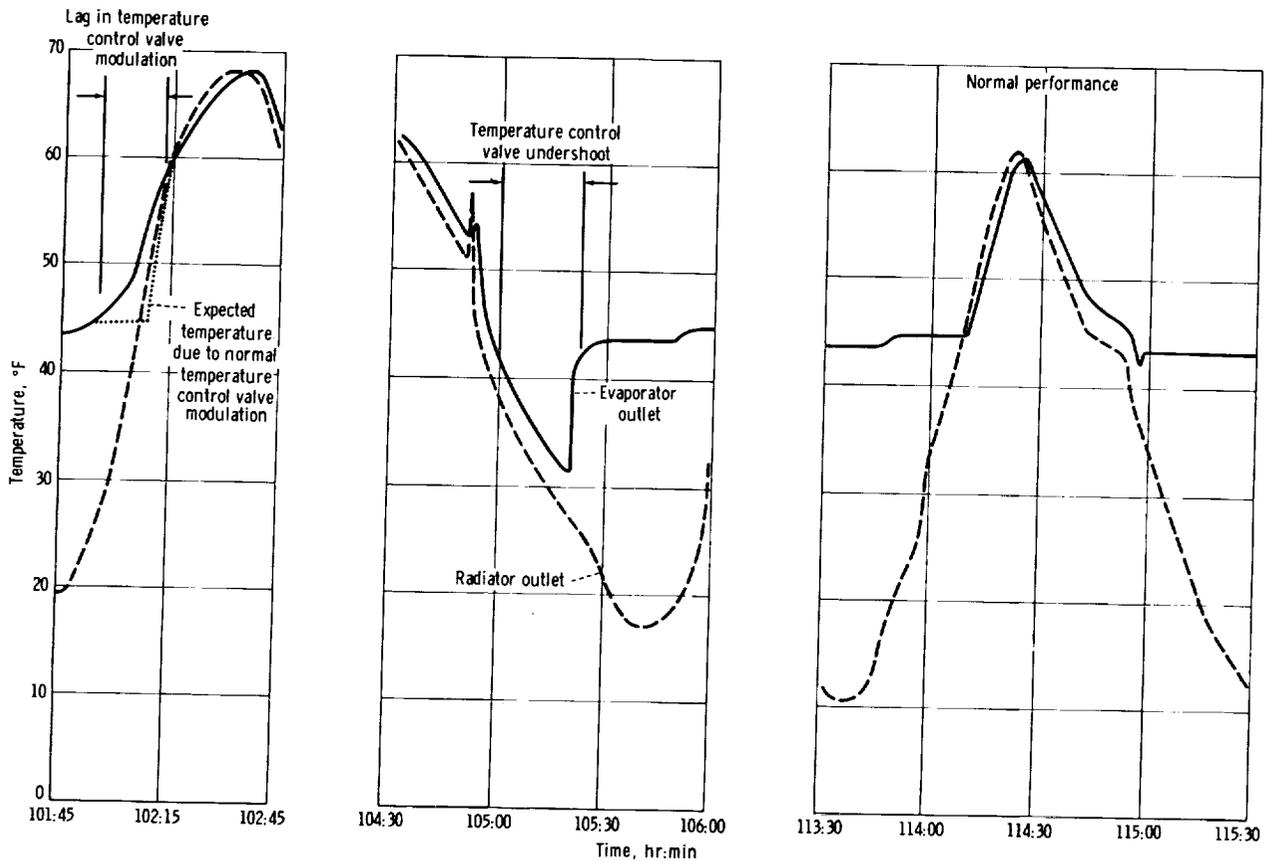
Figure 16-8.- Comparison of radiator and evaporator outlet temperatures.

Two problems occurred on Apollo 11 during lunar orbit operations. First, as the temperature of the water/glycol returning from the radiators increased, the temperature control valve did not close fast enough; thus, an early rise was produced in evaporator outlet temperature. Second, the evaporator outlet temperature decreased to 31° F during revolution 15 as the radiator outlet temperature was rapidly decreasing (fig. 16-8). Figure 16-8 also shows normal operation of the valve and control system after the problem. Both anomalies disappeared at approximately the time during revolution 15 that the glycol evaporator temperature inlet switch was cycled by the crew. The temperature control valve and related control system continued to operate satisfactorily for the remainder of the mission.

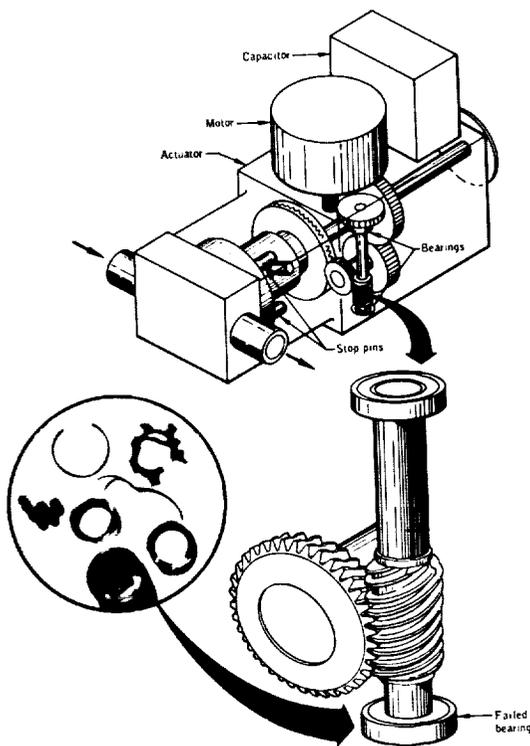
Figure 16-9.- Temperature control valve.

The control valve was removed from the spacecraft, disassembled, and inspected. A bearing within the valve gear train was found to have its retainer disengaged from the race so that the retainer interfered with the worm gear travel (fig. 16-9).

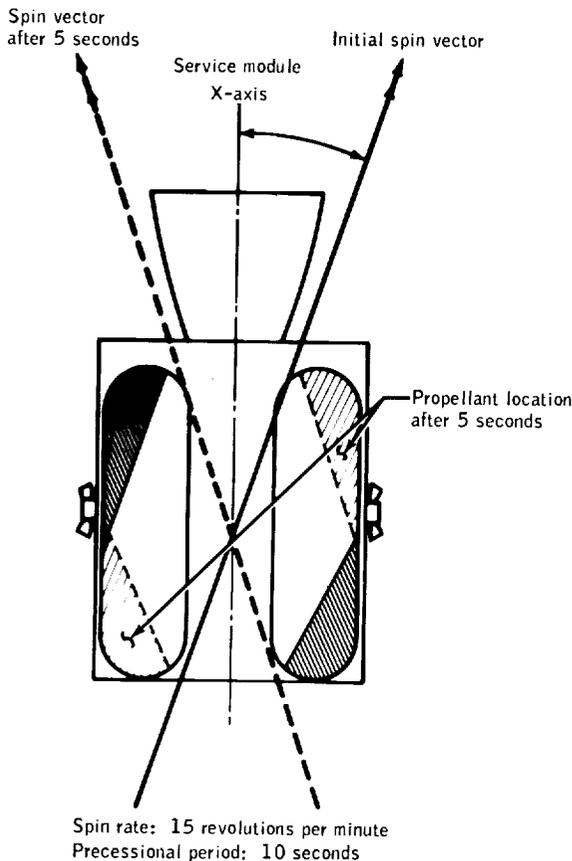
Figure 16-10.- Propellant sloshing effects.

ever, that the service module can become unstable, which results in low net separation velocities. Pictorial representation of the sloshing is shown in figure 16-10. The analyses indicate that tip-off moments applied to the service module at jettison cause the spin vector to precess about the service module X-axis. The precession excites longitudinal sloshing of the propellants in the tanks. Initial propellant locations are shown in heavy shading in figure 16-10. When the spin vector precesses to the other side of the X-axis, the propellants are driven to the other ends of the tanks, as shown in light shading. The sloshing then causes the spin vector to approach a position normal to the service module X-axis. The sloshing effects can cause a reduction in separation velocity, and during the 300-second thrusting period, the service module attitude can be reversed 180°. This condition introduces a remote possibility of recontact between the service module and the command module.

Analysis showed that the optimum separation velocity for a range of propellant loads can be obtained by restricting the roll thrusting to a period of 2 seconds and the X-axis thrusting to a period of 25 seconds. Therefore, beginning with the Apollo 13 mission, the service module jettison controller was modified to give the following jettison sequence.

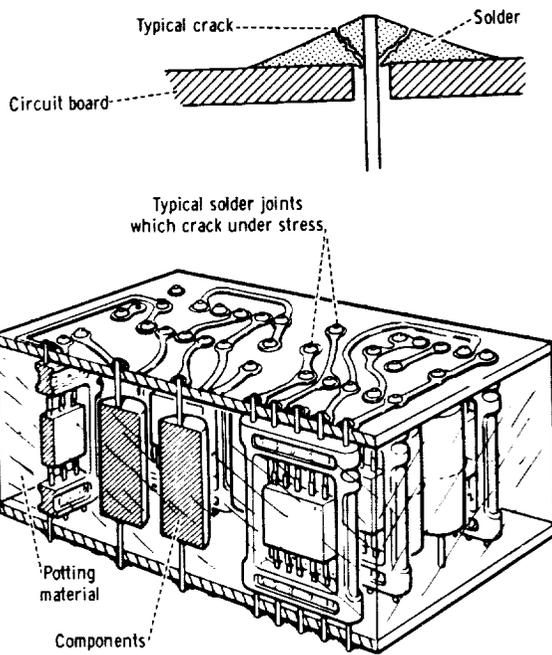
Figure 16-11.- Typical modular construction.

is, electrical components (resistors, capacitors, diodes, etc.) were soldered between two circuit boards, and the void between the boards was filled with potting compound (fig. 16-11). The differential expansion between the potting compound and the component leads caused the solder joints to crack and break electrical contact. Presumably, the 11-hour period the timer was off allowed the timer to cool sufficiently for the cracked joint to make electrical contact, and the timer then operated normally.

Based on the characteristic behavior of the mission timer and the similarity to previous timer failures, the most probable cause of the failure was a cracked solder joint. The reason for the cracked solder joint was the cordwood construction; that

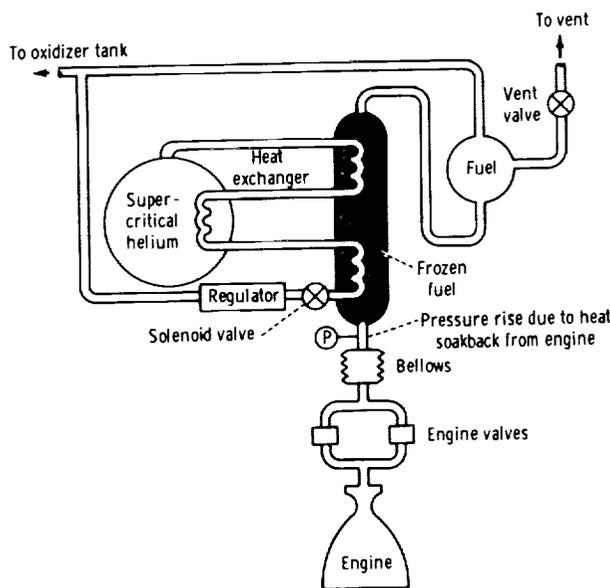
Figure 16-12.- Supercritical helium flow for descent propulsion system.

High fuel interface pressure after landing.- During simultaneous venting of the descent propellant and supercritical helium tanks, fuel in the fuel/helium heat exchanger was frozen by the helium flowing through the heat exchanger. Subsequent heat soakback from the descent engine caused expansion of the fuel trapped in the section of line between the heat exchanger and the engine shutoff valve (fig. 16-12). The result was a pressure rise in this section of line. The highest pressure in the line was probably in the range of 700 to 800 psia. (The interface pressure transducer range is 0 to 300 psia.) The weak point in the system is the bellows links, which yield at pressures greater than 650 psia and fail at approximately 800 to 900 psia. Failure of the links would allow the bellows to expand and relieve the pressure without external leakage. The heat exchanger, which is located in the engine compartment, thawed within approximately 0.5 hour and allowed the line pressure to decay.

On future missions, the solenoid valve (fig. 16-12) will be closed prior to fuel venting and opened some time prior to lift-off. This procedure will prevent freezing of fuel in the heat exchanger and will allow the supercritical helium tank to vent later. The helium pressure rise rate after landing is approximately 3 to 4 psi/hr and constitutes no constraint to presently planned missions. Appropriate changes will be made to operational procedures.

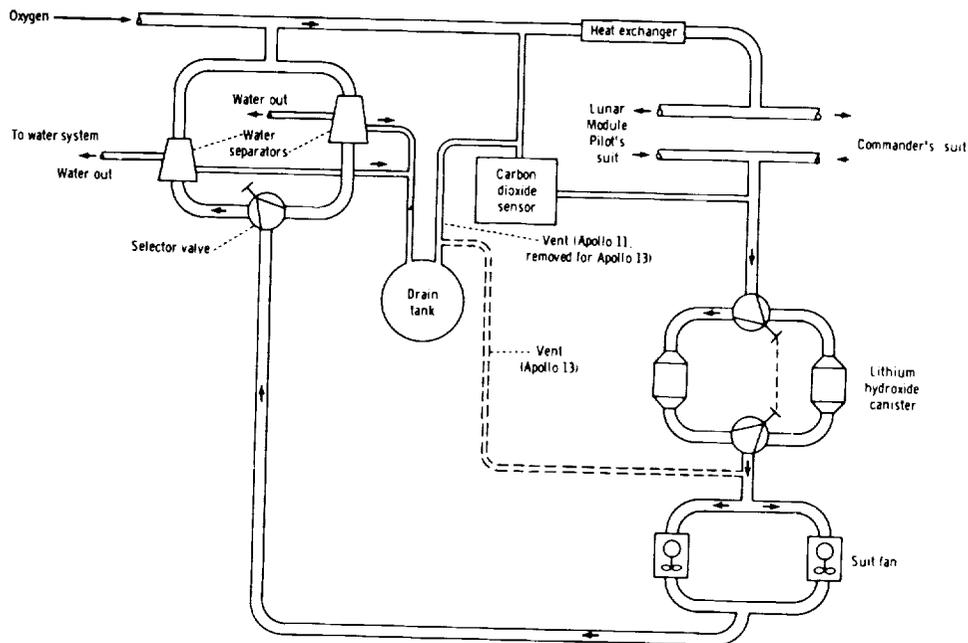
Figure 16-13.- Simplified suit-loop schematic.

into a tank (fig. 16-13). The drain tank contained a honeycomb material designed to retain the condensate. If the amount of condensate exceeded the effective surface of the honeycomb, water could have leaked through the vent line and into the system just up stream of the sensor. (Before the sensor became erratic, the Commander had noted water

The possible sources of free water in the suit loop are the water separator drain tank, an inoperative water separator, local condensation in the suit loop, and leakage through the water separator selector valve (fig. 16-13). An evaluation of each of these possible sources indicated that leakage through the water separator selector valve was the most probable source of the free water.

in his suit.) Free water in the optical section of the sensor will cause erratic performance. The carbon dioxide content is sensed by measuring the light transmission across a stream of suit-loop gas. Any liquid in the element affects the light transmission and thus gives improper readings. To preclude water being introduced into the sensor from the drain tank, the vent line was relocated to an existing boss upstream of the fans, effective on Apollo 13 (fig. 16-13).

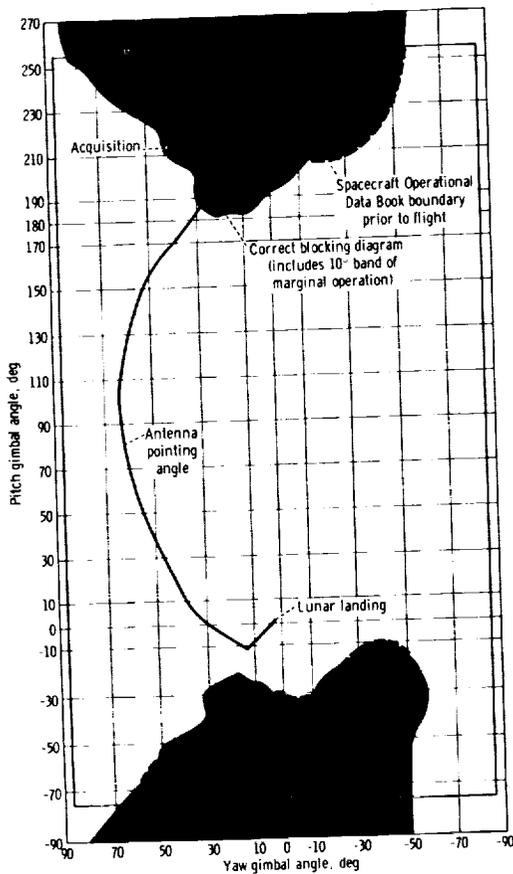
Figure 16-14.- Coverage restrictions for S-band steerable antenna.

For the pointing angles used, errors were discovered in the antenna coverage restriction diagram in the Spacecraft Operational Data Book. In addition, the diagram failed to include the thruster plume deflectors, which were added to the lunar module at the launch site. Figure 16-14 shows the correct blockage diagram and the diagram that was used in the Spacecraft Operational Data Book prior to flight. The pointing angles of the antenna were in an area of blockage or sufficiently close to blockage to affect the coverage pattern. As the antenna boresight approaches the vehicle structure, the on-boresight gain is reduced, the selectivity to incoming signals is reduced, and sidelobe interference is increased. Furthermore, a preflight analysis showed that the multipath signal, or reflected ray (fig. 16-15), from the lunar surface to the vehicle flight trajectory would be sufficient to cause some of the antenna tracking losses. Also, the reduction in antenna selectivity caused by vehicle blockage increases the probability of multipath interferences in the antenna tracking circuits. In conclusion, both the vehicle blockage and the multipath signals probably contributed to the reduced measured signal.

For future missions, the correct vehicle blockage and multipath conditions will be determined for the predicted flight trajectory. Operational measures can be employed to reduce the probability of the recurrence of this problem by selecting vehicle attitudes that orient the antenna away from vehicle blockages and by selecting vehicle attitude hold with the antenna track mode switch in the SLEW or MANUAL position throughout the time periods when this problem may occur.

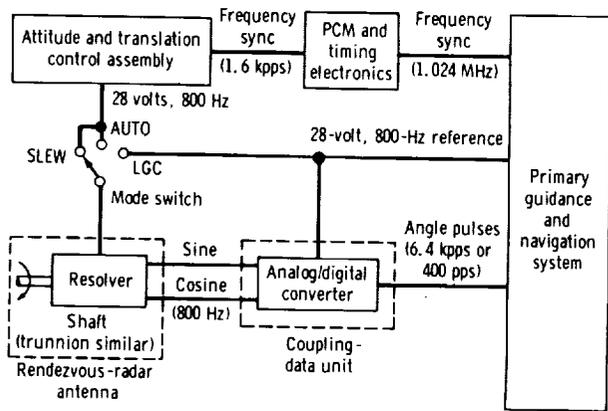
Figure 16-16.- Interfaces from rendezvous-radar antenna to primary guidance system.

The alarms were of the Executive overflow type, which signify that the guidance computer cannot accomplish all of the data processing requested in a computation cycle. The alarms indicated that more than 10 percent of the computation capacity of the computer was preempted by unexpected counter interrupts of the type generated by the rendezvous-radar shaft and trunnion resolvers (fig. 16-16).

The interrupts during the powered descent resulted from the configuration of the rendezvous-radar/coupling data unit/computer interface. A schematic of the interface is shown in figure 16-16. When the rendezvous-radar mode switch is in the AUTO or SLEW position, the excitation for the radar shaft and trunnion resolvers is supplied by a 28-volt, 800-hertz signal from the attitude and translation control assembly. When the switch is in the LGC position, the positioning of the radar antenna is controlled by the guidance computer, and the resolver excitation is supplied by a 28-volt, 800-hertz source in the primary guidance and navigation control system. The output signals of the shaft and trunnion resolvers interface with the coupling data units, regardless of the excitation source. The attitude and translation control assembly voltage is locked in frequency with the primary guidance and navigation control system voltage through control (by the primary guidance and navigation control system) of the PCM and timing electronics frequency, but it is not locked in phase. When a mode switch is not in LGC, the attitude and translation control assembly voltage is the source for the resolver output signals to the coupling data units, while the primary guidance and navigation control system 800-hertz voltage is used as a reference voltage in the analog-to-digital conversion portion of the coupling data unit. Any difference in phase or amplitude between the two 800-hertz voltages will cause the coupling data unit to recognize a change in shaft or trunnion position, and the coupling data unit will "slew" (digitally). The "slewing"

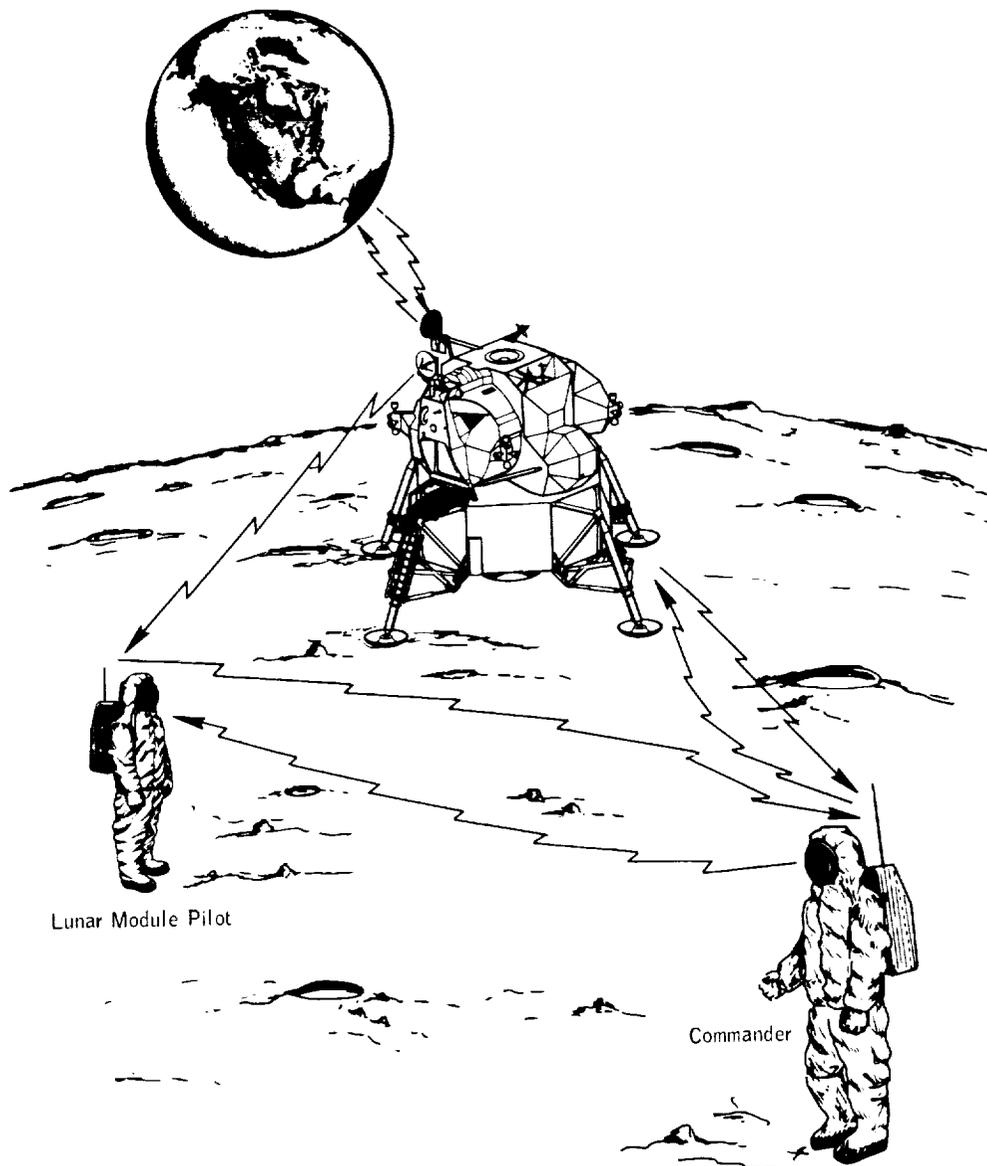
Echo during extravehicular activity.- A voice turnaround (echo) was heard during extravehicular activity. At that time, the lunar module was operating in a relay mode. Up-link voice from the S-band was processed and retransmitted to the two extravehicular crewmen by means of the lunar module vhf transmitter. Crew voice and data were received by the lunar module vhf receiver and relayed to the earth by means of the lunar module S-band transmitter (fig. 16-18). The echo, which was duplicated in the laboratory, resulted from mechanical acoustical coupling between the communications carrier earphone

Figure 16-18.- Communications relays during extravehicular activity.

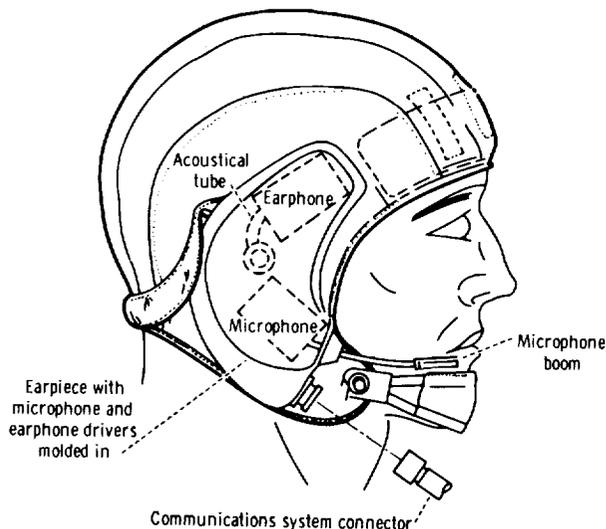
and microphone (fig. 16-19). The crewmen indicated that their volume controls were set at maximum during the extravehicular activity. This setting would provide a level of approximately +16 dBm into each crewman's earphones. Isolation between earphones and microphones, exclusive of airpath coupling, is approximately 48 decibels. Therefore, at the microphone output, the ground voice signal would appear at a level of approximately -32 dBm. If it is assumed that extravehicular communications keying was enabled, this signal would be processed and transmitted by the extravehicular communications system and would provide a level of approximately -12 dBm at the output of the lunar module vhf receiver. If the lunar module relay was enabled, this signal would be amplified and relayed to earth by means of the S-band at a nominal output level.

Figure 16-19.- Communications carrier.

Both voice-operated keying circuits were also keyed by bumping or rubbing of the communications carrier against the helmet. The random echo problem is inherent in the communications system design, and there does not appear to be any practical way to eliminate random voice-operated keying or to significantly reduce the acoustical coupling in the communications carrier.

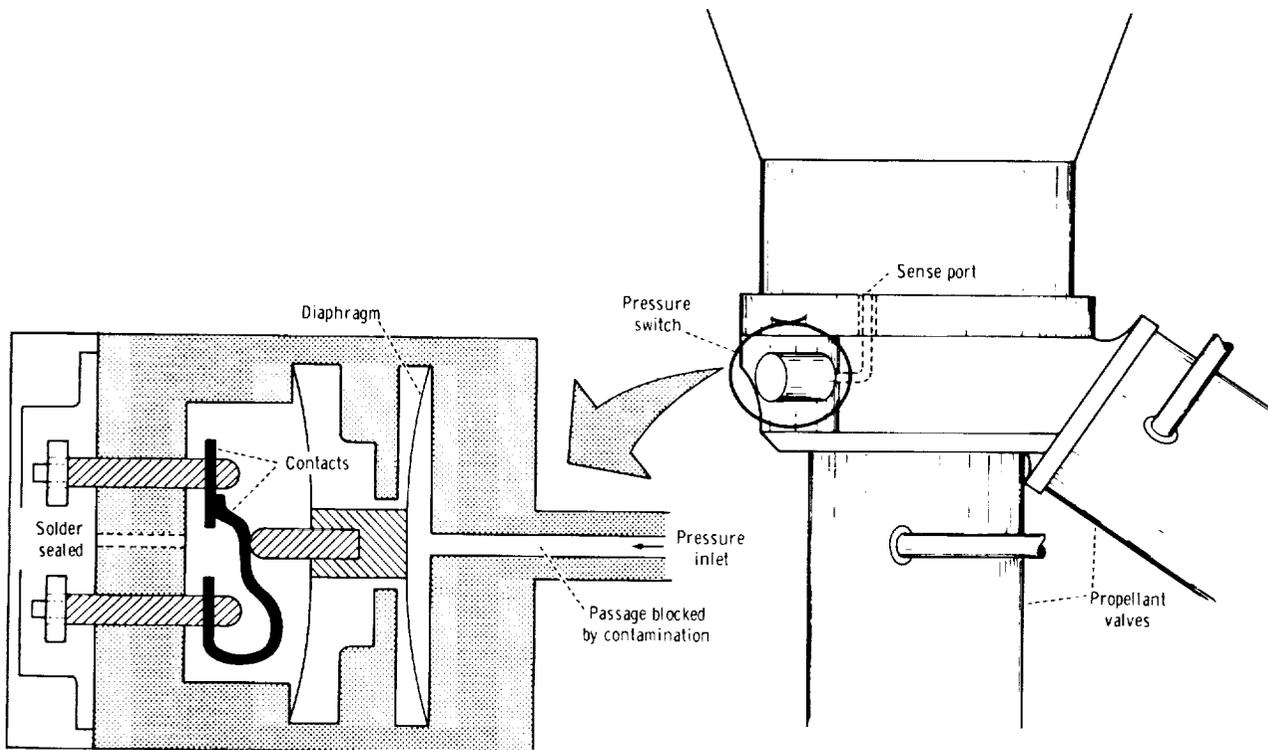
Thrust chamber pressure switches.- The switch used to monitor the quad 2 aft-firing engine (A2A) exhibited slow response to jet driver commands during most of the mission. During an 18-minute period just prior to terminal phase initiation, the switch failed to respond to seven consecutive minimum-impulse commands. This failure resulted in a master alarm and a thruster warning flag, both of which were reset by the crew. The engine operated normally, and the switch failure had no effect on the mission. The crew did not attempt any investigative procedures to determine whether the engine had actually failed. A section drawing of the switch is shown in figure 16-20.

Figure 16-20.- Chamber pressure switch.

This failure was the first of its type to be observed in flight or in ground testing. The switch closing response (time of jet driver ON command to switch closure) appeared to increase from an average of approximately 15 to 20 milliseconds during station keeping to 25 to 30 milliseconds at the time of failure. Normal switch closing response is 10 to 12 milliseconds, based on ground test results. The closing response remained at the 25- to 30-millisecond level following the failure, and the switch continued to fail to respond to some minimum-impulse commands. The switch opening time (time from jet driver OFF command to switch opening) appeared to be normal throughout the mission. In view of these results, the most probable cause of the switch failure was particulate contamination in the inlet passage of the switch. Contamination in this area would reduce the flow rate of chamber gases into the diaphragm cavity, thereby reducing the switch closing response. However, the contamination would not necessarily affect switch opening response because normal chamber pressure tailoff requires approximately 30 to 40 milliseconds in order to decrease from approximately 30 psia to the normal switch opening pressure of approximately 4 psia. The 30- to 40-millisecond time would probably be sufficient to allow the gases in the diaphragm cavity to vent such that the switch would open normally. The crews for future missions will be briefed to recognize and handle similar situations.

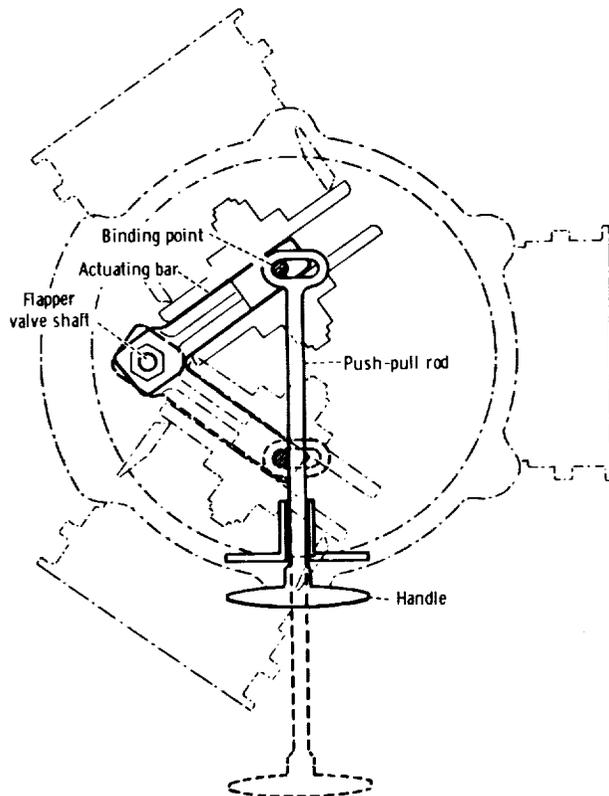
The flapper-type valve is located in a Y-duct arrangement and is used to select one of two water separators. Leakage of this valve would allow free water to pass through the idle water separator and subsequently enter the suit hose. This leakage would most probably result from a misalignment and binding in the slot of the selector valve actuation linkage (fig. 16-21).

Figure 16-21.- Water separator selector valve.

The allowable actuation force after linkage rigging was 15 pounds. The usual actuation forces have been 7 to 8 pounds, but 12.5 pounds were required on the Apollo 11 mission. The allowable actuation force has been lowered to 10 pounds, and inspections for linkage binding have been incorporated into procedures at the factory and the launch site.

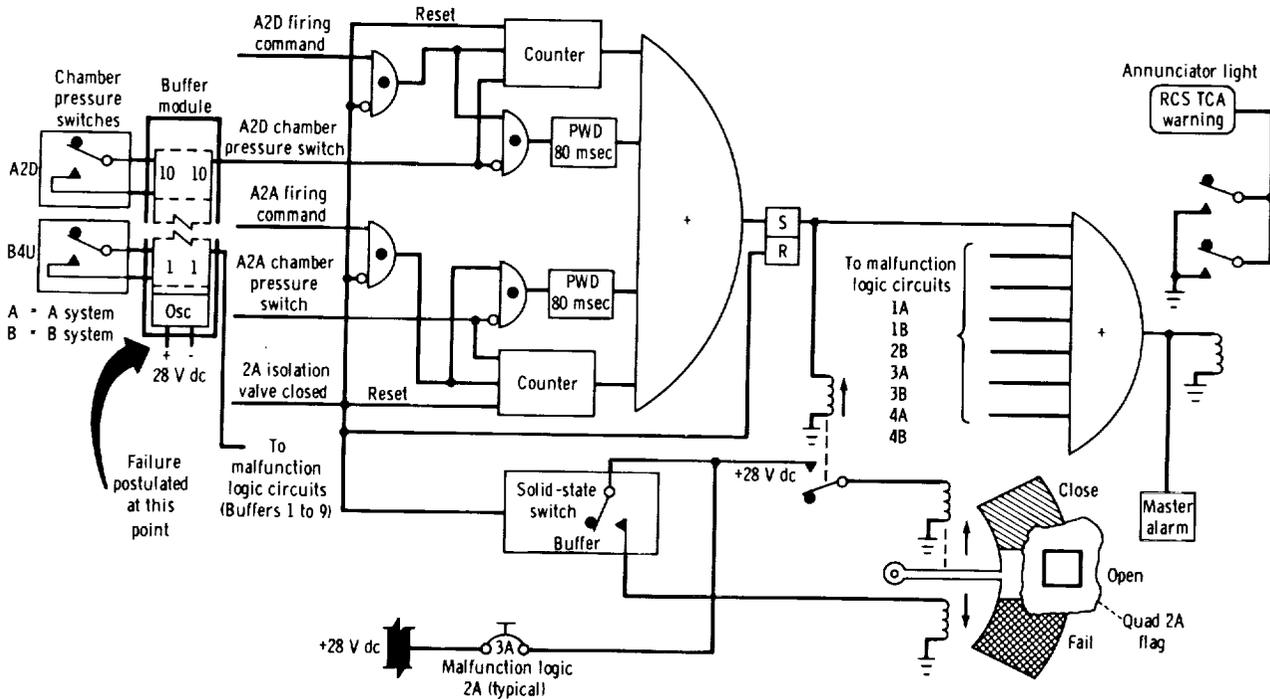
The first two possible causes are unlikely because simultaneous multiple failures would have to occur and subsequently be corrected. The third possible cause is the most likely to have occurred where a single-point failure existed. Ten of the 16 engine pressure switch outputs are conditioned by the 10 buffers in one module in the signal conditioner electronics assembly (fig. 16-22). This module is supplied with +28 V dc through one wire. In addition, the module contains an oscillator that provides an

Figure 16-22.- Reaction control system malfunction-detection circuits.

ac voltage to each of the 10 buffers. If either the +28 V dc is interrupted or the oscillator fails, none of the 10 buffers will respond to pressure switch closures. If engines monitored by these buffers are then commanded on, the corresponding warning flags will appear, and a master alarm will occur.

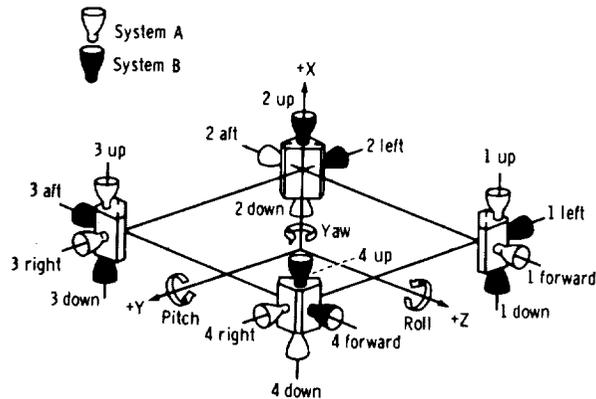
If plus X translation were commanded (fig. 16-23), the down-firing engines in quads 2 and 4 of system A could fire, and flags 2A and 4A would appear. A subsequent minus X rotation could fire the forward-firing thruster in quad 4 of system B and the aft-firing thruster in quad 2 of system A, and flag 4B would appear. The aft-firing engine in quad 2 of system A (A2A) is not monitored by one of the 10 buffers postulated as having failed. The failure, then, could have cleared itself. The response of the vehicle to thruster firings would have been normal under these conditions. There is no history of similar failures either at package or module level in the signal conditioner electronics assembly. No corrective action was taken.

Figure 16-23.- Reaction control system geometry.

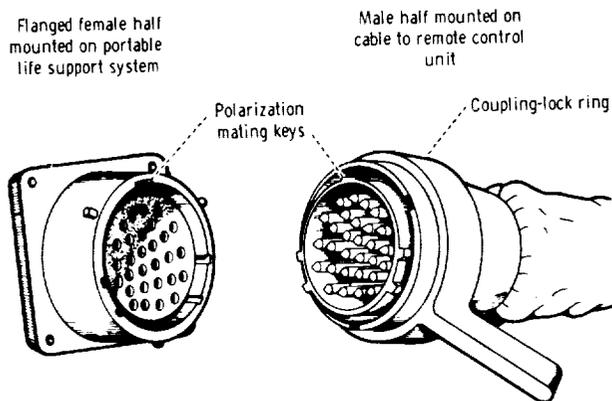
Mating of remote control unit to portable life support system.- During preparation for extravehicular activity, the crew experienced considerable difficulty in mating the electrical connectors from the remote control unit to the portable life support system. For rotational polarization alignment, it was necessary to grasp the cable insulation because the coupling lock ring was free for unlimited rotation on the connector shell (fig. 16-24).

Figure 16-24.- Connector between remote control unit and portable life support system.

For future missions, the male half of the connector has been replaced with one that has a coupling lock ring with a positive rotational position with the connector shell and that can be grasped for firm alignment of the two halves. The ring is then rotated 90° in order to capture and lock the two halves. In addition, easier insertion has been attained with conical-tipped contact pins in place of hemispherical-tipped pins.
